LOGISTICS ACTIVITY  
NORTH VIETNAM  
1 NOVEMBER - 31 DECEMBER  
1968

NPIC/R-7/69  
JANUARY 1969

NATIONAL PHOTOGRAPHIC INTERPRETATION CENTER

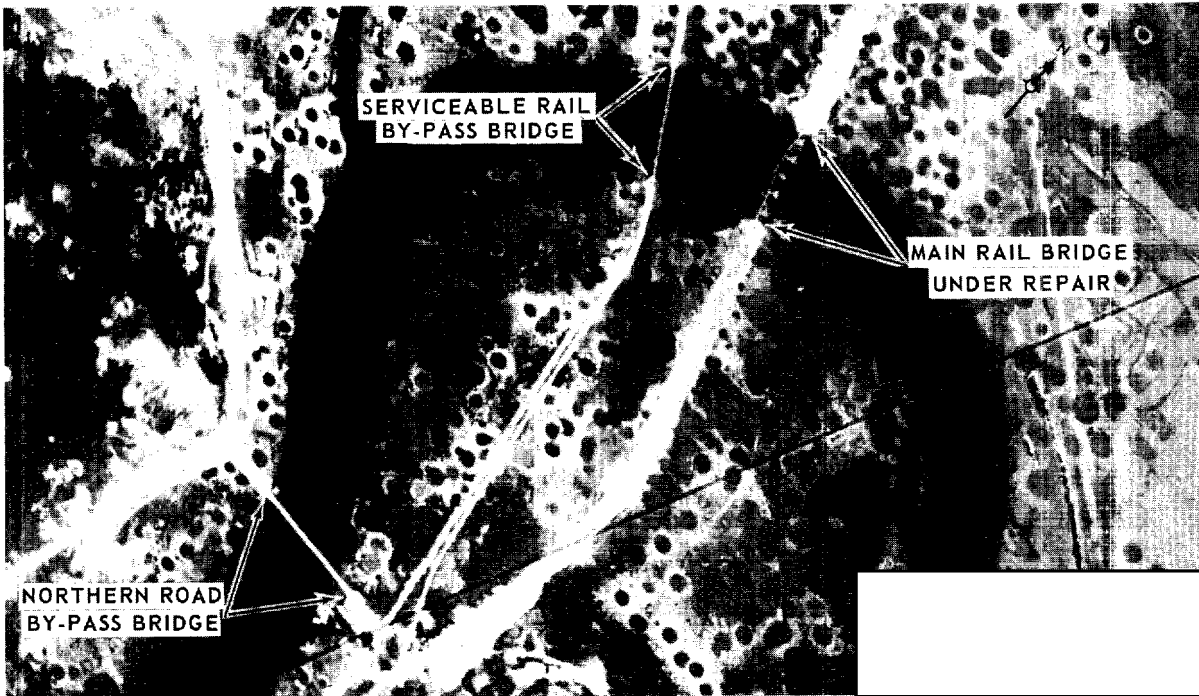
FIGURE 2. MAIN RAIL BRIDGE REPAIR, THANH HOA-VINH RAIL LINE, TAM DA, NORTH VIETNAM.

Large amounts of supplies are being moved by rail during daylight hours to support the North Vietnamese forces in the south (Figure 1). At the present time, the southern hub of rail shipments is the Thanh Hoa railyard complex. Prior to 1 November, this was also the southern terminus for conventional rolling stock. Since the bombing halt the critical rail by-pass bridges at Phu Dien Chau and Tam Da on the Thanh Hoa to Vinh line have been repaired and conventional stock is now moving to Vinh. The conventional stock arriving in Thanh Hoa is either offloaded for later movement south by lorry train or reclassified and moved to Vinh by small diesel switch engines capable of negotiating the rail by-pass bridges. Extensive repair activity is observed at the main Tam Da rail bridge on [redacted] photography (Figure 2). When completed, the

bridge will enable the heavier steam locomotives to continue through to Vinh.

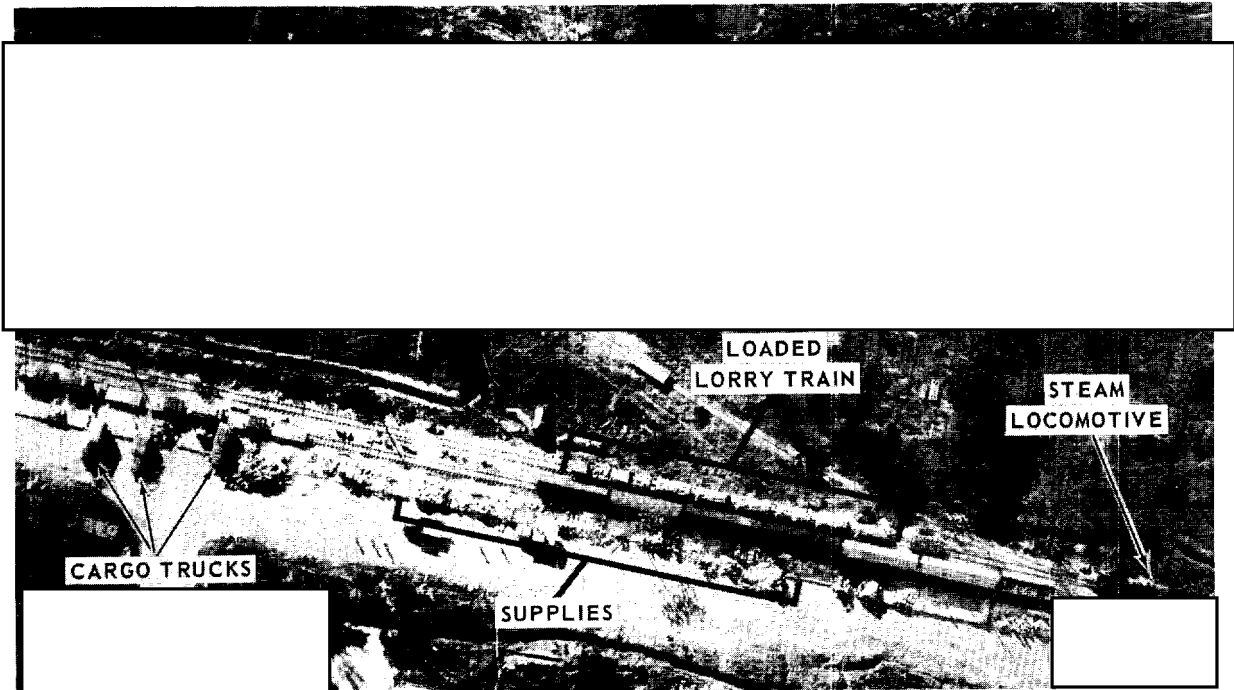
FIGURE 3. THANH HOA RAILROAD YARD, NORTH VIETNAM.

Photography [redacted] revealed 197 pieces of serviceable conventional rolling stock, 107 two-axle lorry cars, eight steam locomotives, and seven lorries in Thanh Hoa. These totals

[redacted] observed in Thanh Hoa in recent years. Supplies observed included sacked goods, crated materials, POL drums and tanks, and vehicle tires (Figure 3). The amount of activity observed [redacted] is comparable to the peak of activity reached subsequent to the 31 March 1968 bombing halt when Thanh Hoa became a sanctuary by virtue of its location north of the 19th parallel.

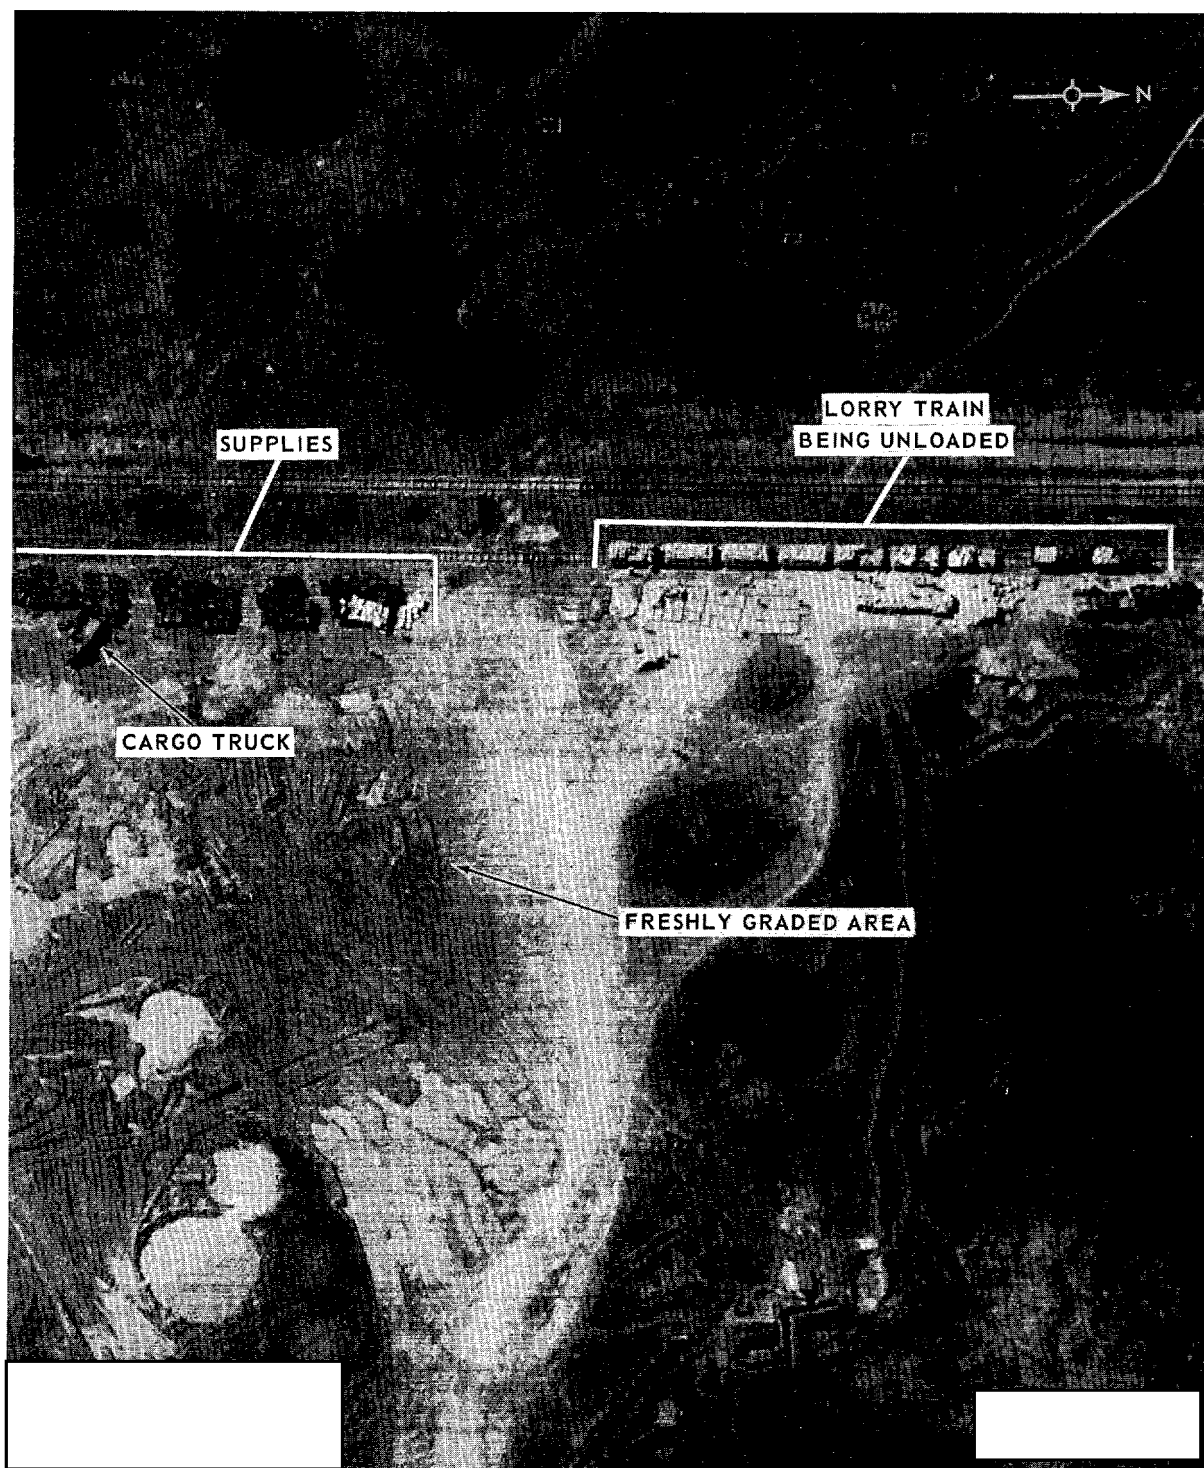
FIGURE 4. VINH RAILROAD YARD, NORTH VIETNAM.

The rail line from the 19th parallel to Vinh was serviceable for light-capacity lorry trains as [redacted] and for conventional rolling stock shortly thereafter. Both southbound and northbound trains have been observed using the line. The Vinh Railyard has been reactivated as a transshipping area and the storage yard has been freshly graded [redacted]. A lorry train was observed being unloaded [redacted] and conventional stock has been observed in the yard continually [redacted]. Photography [redacted] revealed large quantities of supplies being stacked in the storage yard, probably to await shipment further south by cargo truck (Figure 4).

The repair of the Vinh rail line and railyard suggests that some of the transshipping activity formerly at Thanh Hoa has been relocated to Vinh and that with further repairs, greater amounts of conventional rolling stock will be observed moving to the Vinh rail complex.

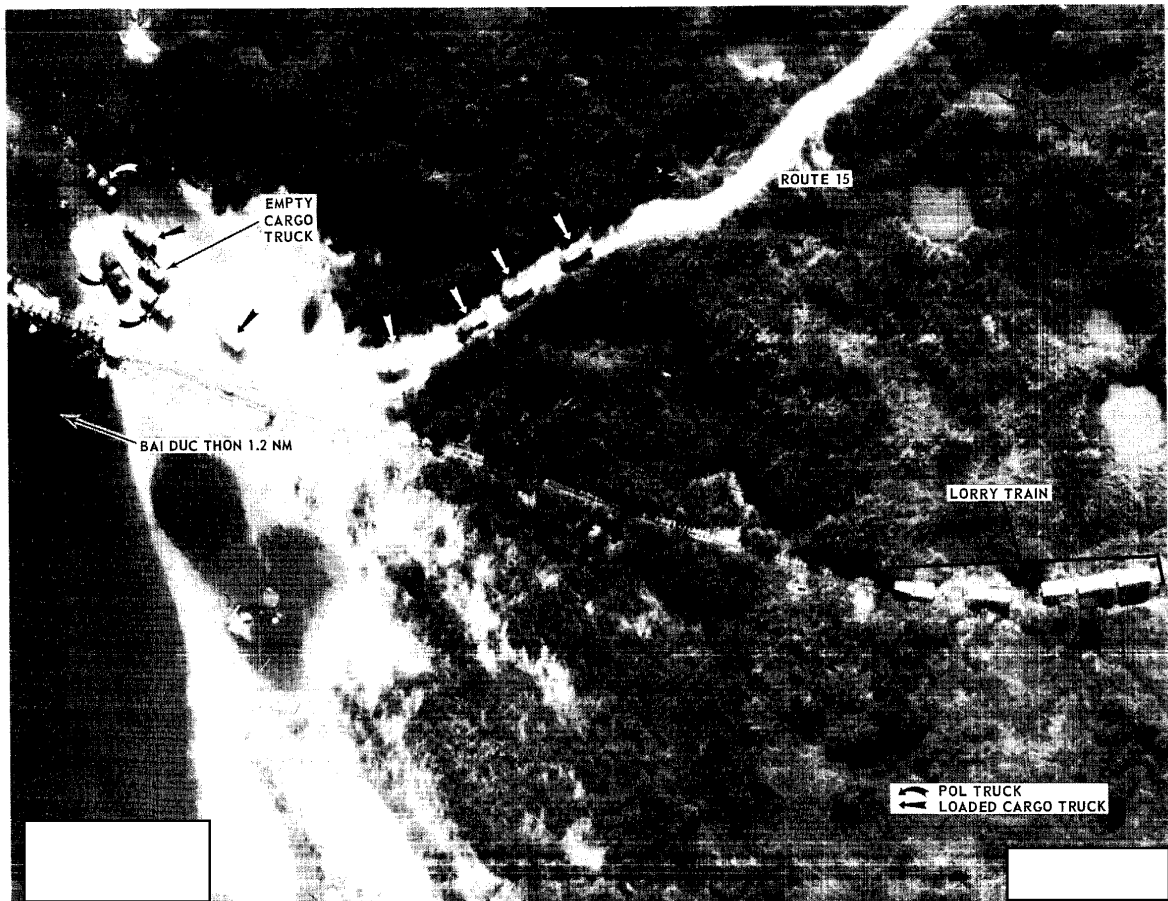
FIGURE 5. VINH-DONG HOI RAIL LINE, BAI DUC THON, NORTH VIETNAM.

Photography [redacted] reveals that repair activity is continuing on segments of the rail line from Vinh to Bai Duc Thon and further south. One segment just north of Bai Duc Thon is being used at the present time to supplement vehicles in carrying supplies into the Bai Duc Thon area (Figure 5).

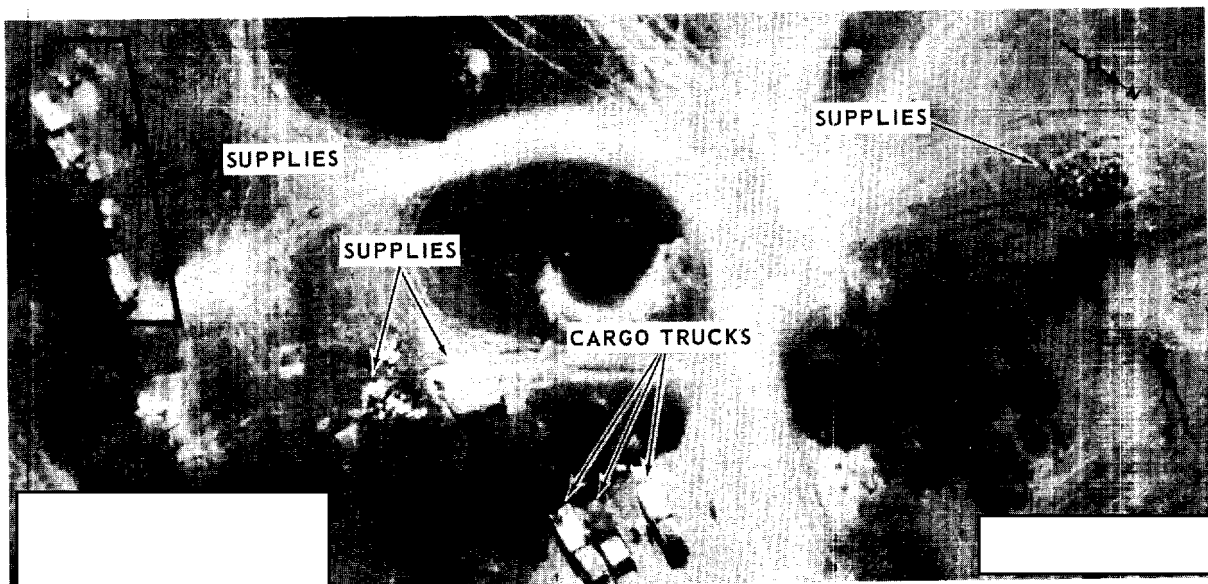
FIGURE 7. STORAGE AREA, BAI DUC THON, NORTH VIETNAM.

In support of the smooth flow of traffic, rest, refueling, and staging areas are required. One of the most notable is in the Bai Duc Thon area where increased activity has been observed. When

first identified [redacted] it was the largest area of its kind in North Vietnam. It now contains extensive vehicle refueling facilities, several transshipping areas, and large open storage areas with numerous stacks of supplies (Figure 7). There appears to be considerable transshipping activity in this vicinity, since the trucks arriving from the south are empty and those from the North are loaded. This activity is apparently in support of a resupply effort at least partially using the Mu Gia Pass and the Laos road net at night. Vehicles destined for Routes 101 and 137 may also utilize these facilities.

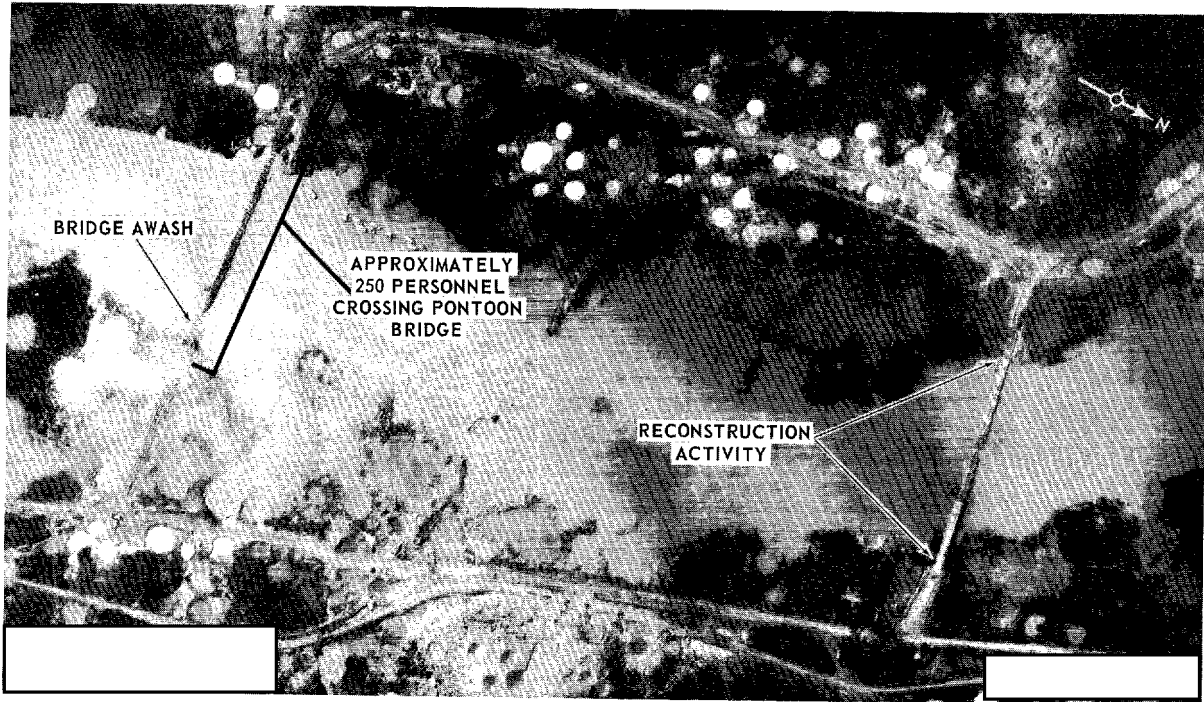
FIGURE 8. RIVER CROSSING ACTIVITY, TAM DA, NORTH VIETNAM.

In most areas where routes had been interdicted, extensive repair is underway to keep the traffic moving. An example of this activity is at Tam Da where Route 1A crosses the Song Cua Lo, as does the rail line from Thanh Hoa to Vinh. Photography [redacted] revealed that a temporary pontoon type bridge was being used by northbound and southbound convoys and reconstruction activity was noted on one of the road by-pass bridges. Three days later approximately 250 personnel were observed crossing the pontoon bridge and reconstruction activity was continuing on the by-pass bridge (Figure 8). Coverage [redacted] showed the by-pass bridge serviceable and carrying traffic. More recent photography reveals that the pontoon bridge has been removed.

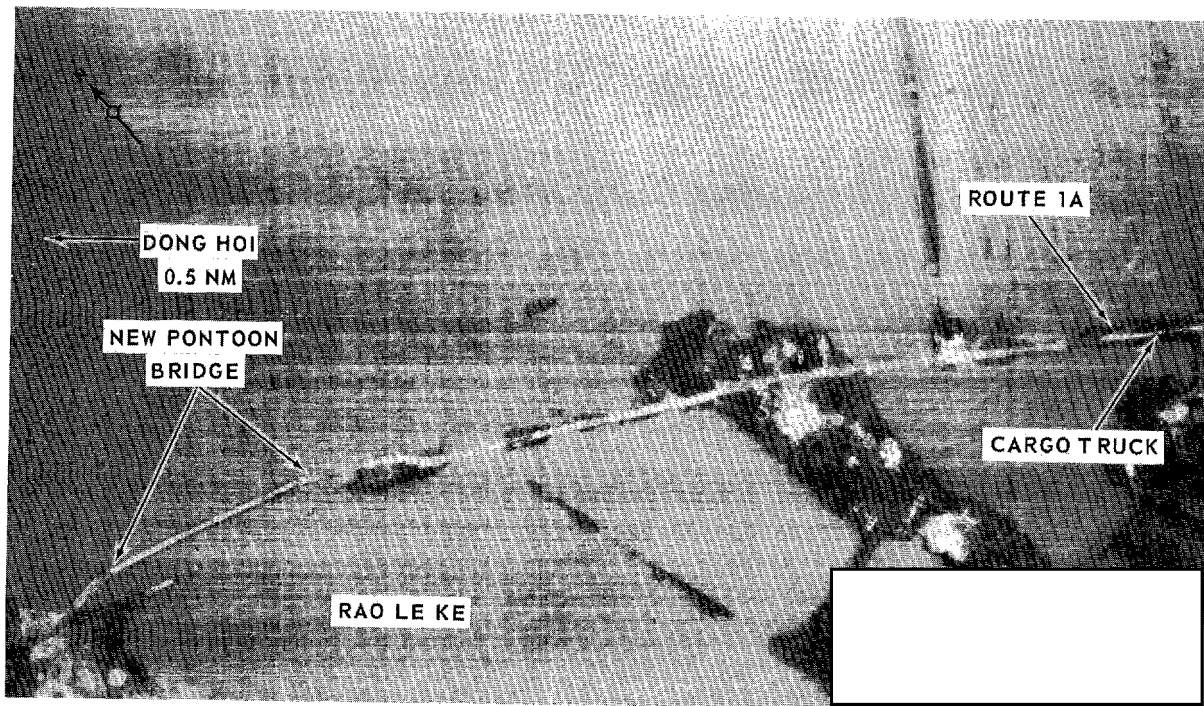
FIGURE 9. DONG HOI HIGHWAY BRIDGE, ROUTE 1A, NORTH VIETNAM.

A pontoon bridge has been newly constructed in the Dong Hoi area to facilitate the movement of supplies along Route 1A (Figure 9). In addition, storage areas are being constructed in the Dong Hoi area and to the south to handle much of the material that is being moved into this area (Figure 10). Photography [redacted] provides indications of increasing activity in the area between Dong Hoi and the DMZ. Transshipment points newly constructed [redacted] are active and vehicle activity is continuing at a high level.

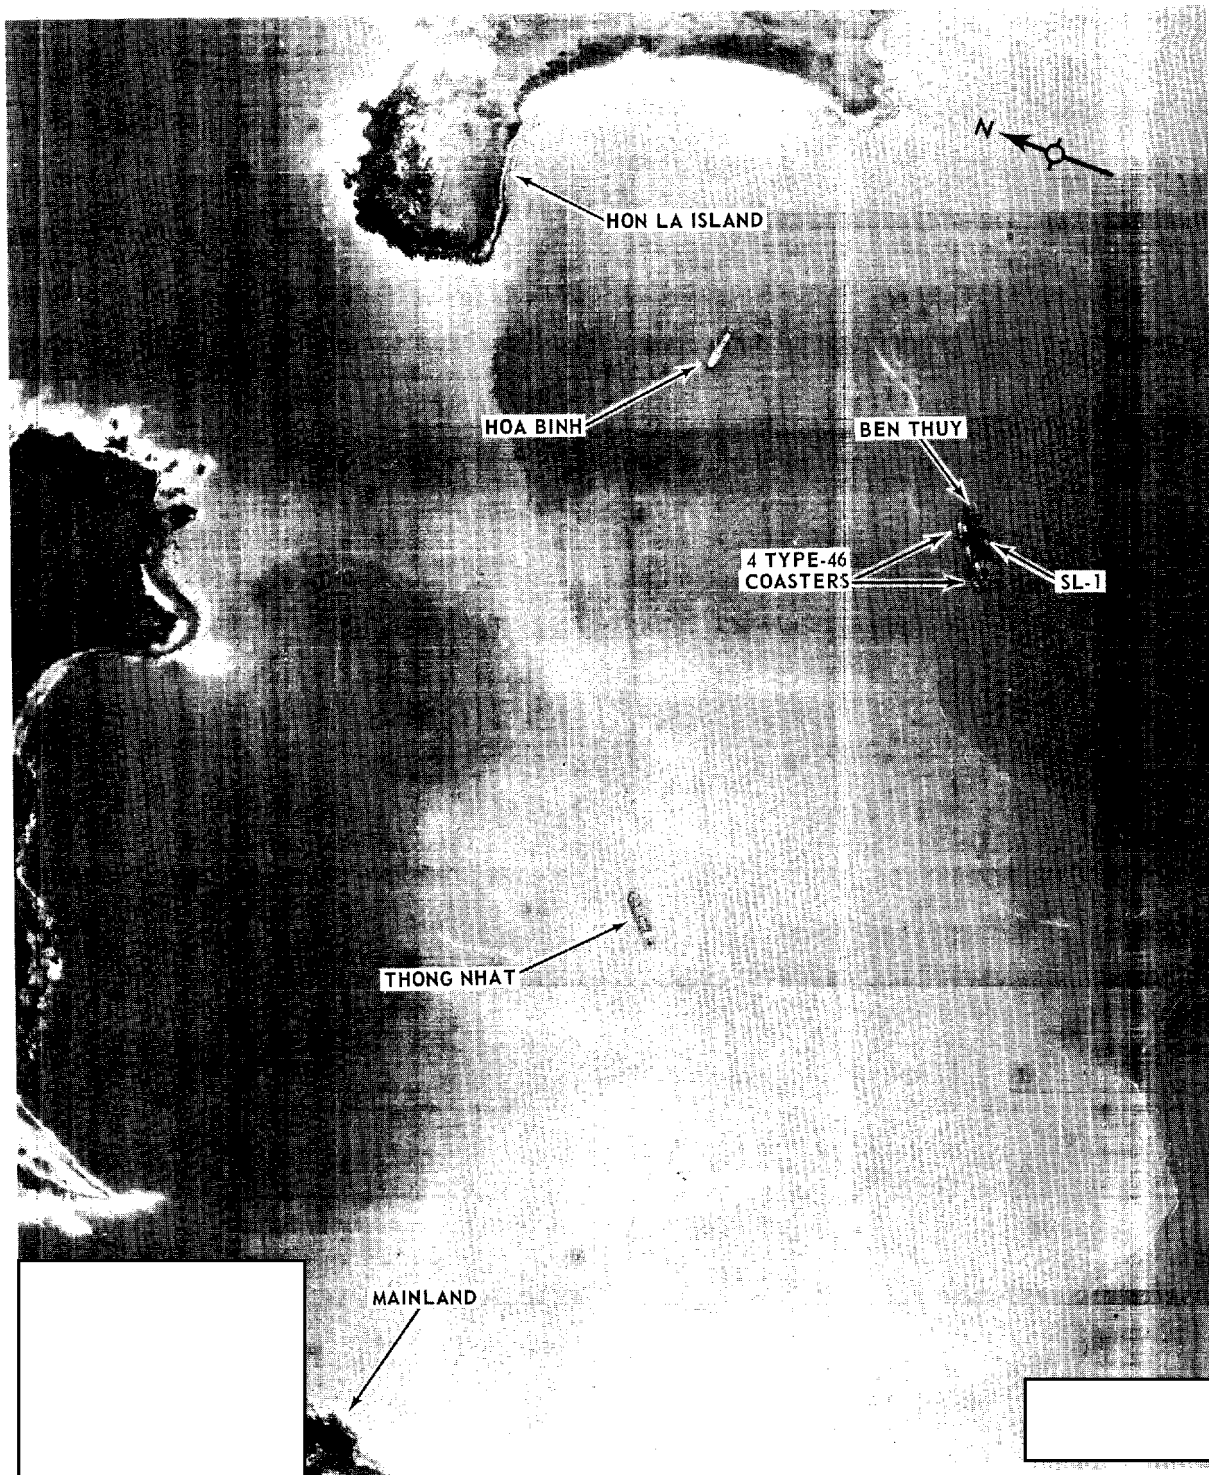
FIGURE 12. NVN MERCHANT SHIPS, HON LA ISLAND, NORTH VIETNAM.

"Ben Thuy", "Hoa Binh", and "Thong Nhat" were photographed in an anchorage at Hon La Island, 14.5 nm NNE of Quang Khe. The "Ben Thuy" and "Hoa Binh" were observed in Haiphong.

At the Hon La anchorage, the "Ben Thuy" was observed transloading supplies into four Type-46 coasters and an SL-1 (small logistics vessel). The "Hoa Binh" and "Thong Nhat" were riding low in the water with the hatches closed and the latter had more than 250 POL drums on deck (Figure 12). The three freighters can carry an aggregate total of approximately 4,200 tons. Throughout the months of

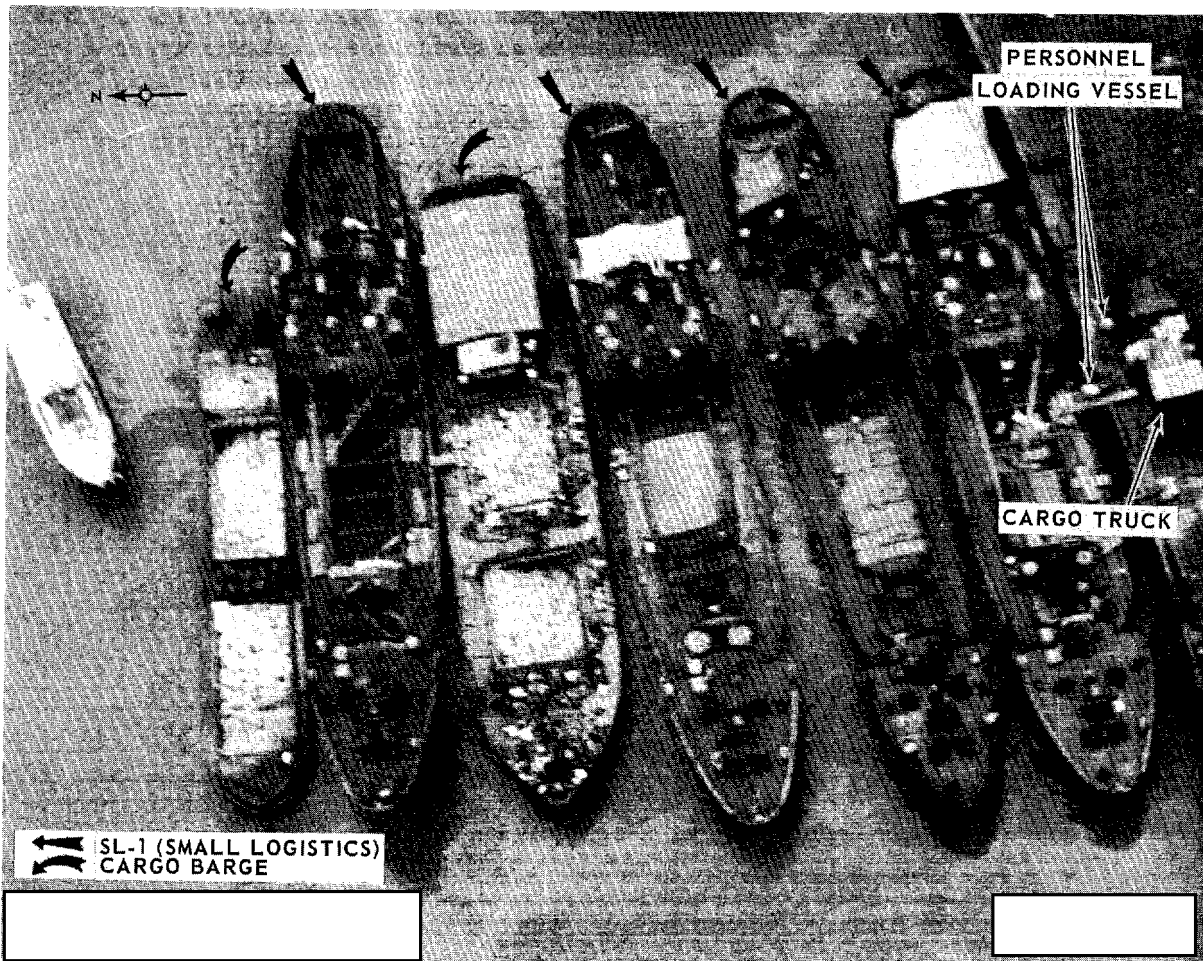
FIGURE 13. SL-1 VESSELS LOADING SUPPLIES, HAIPHONG, NORTH VIETNAM.

SL-1s have been taking on supplies in Haiphong (Figure 13) at berths normally occupied by ocean-going freighters being unloaded. This type of activity involving SL vessels had not been identified prior to the bombing halt. These supplies were probably destined for movement south since subsequent photography has revealed many of the same type vessels operating in and around Quang Khe.

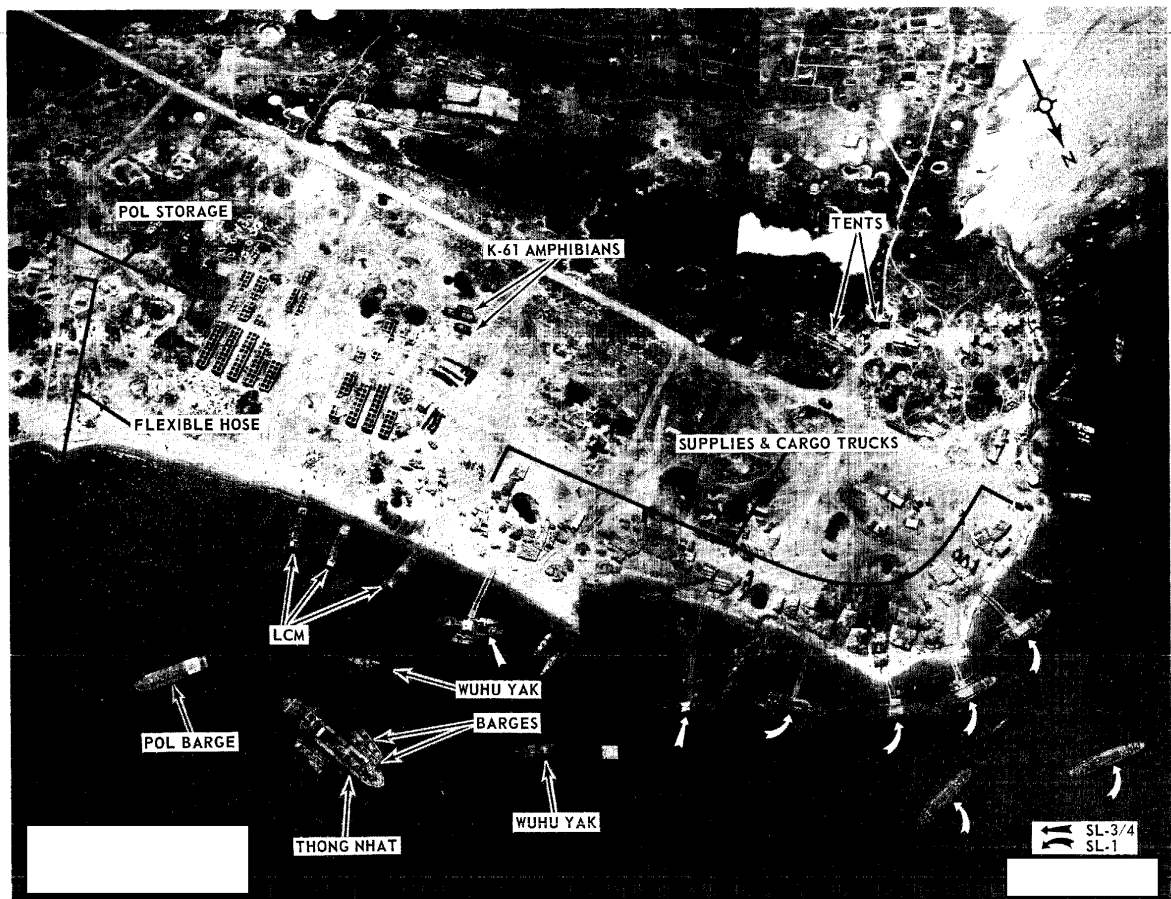
FIGURE 14. QUANG KHE TRANSSHIPMENT POINT, NORTH VIETNAM.

Extensive reconstruction and other activity is observed at several transshipment areas at Quang Khe, Dong Hoi, Vinh, and Thanh Hoa. Quang Khe is apparently developing as the southern terminus for the SL vessels and the large North Vietnamese freighters. The SL vessels leave Haiphong and proceed to Quang Khe where they are offloaded, and their cargoes probably broken down and shipped further south. The freighters normally proceed as far south as Hon La Island where they are lightered and the cargo taken to Quang Khe. However, the "Thong Nhat" has been seen anchored at Quang Khe directly offshore. Intensive activity is observed at Quang Khe. Stacks of supplies line the bank and a POL storage area with an offshore POL transfer system with a flexible hose has been constructed. Several shelters for workers have also been erected (Figure 14). 21 SL craft were observed at Quang Khe, the highest number to date.

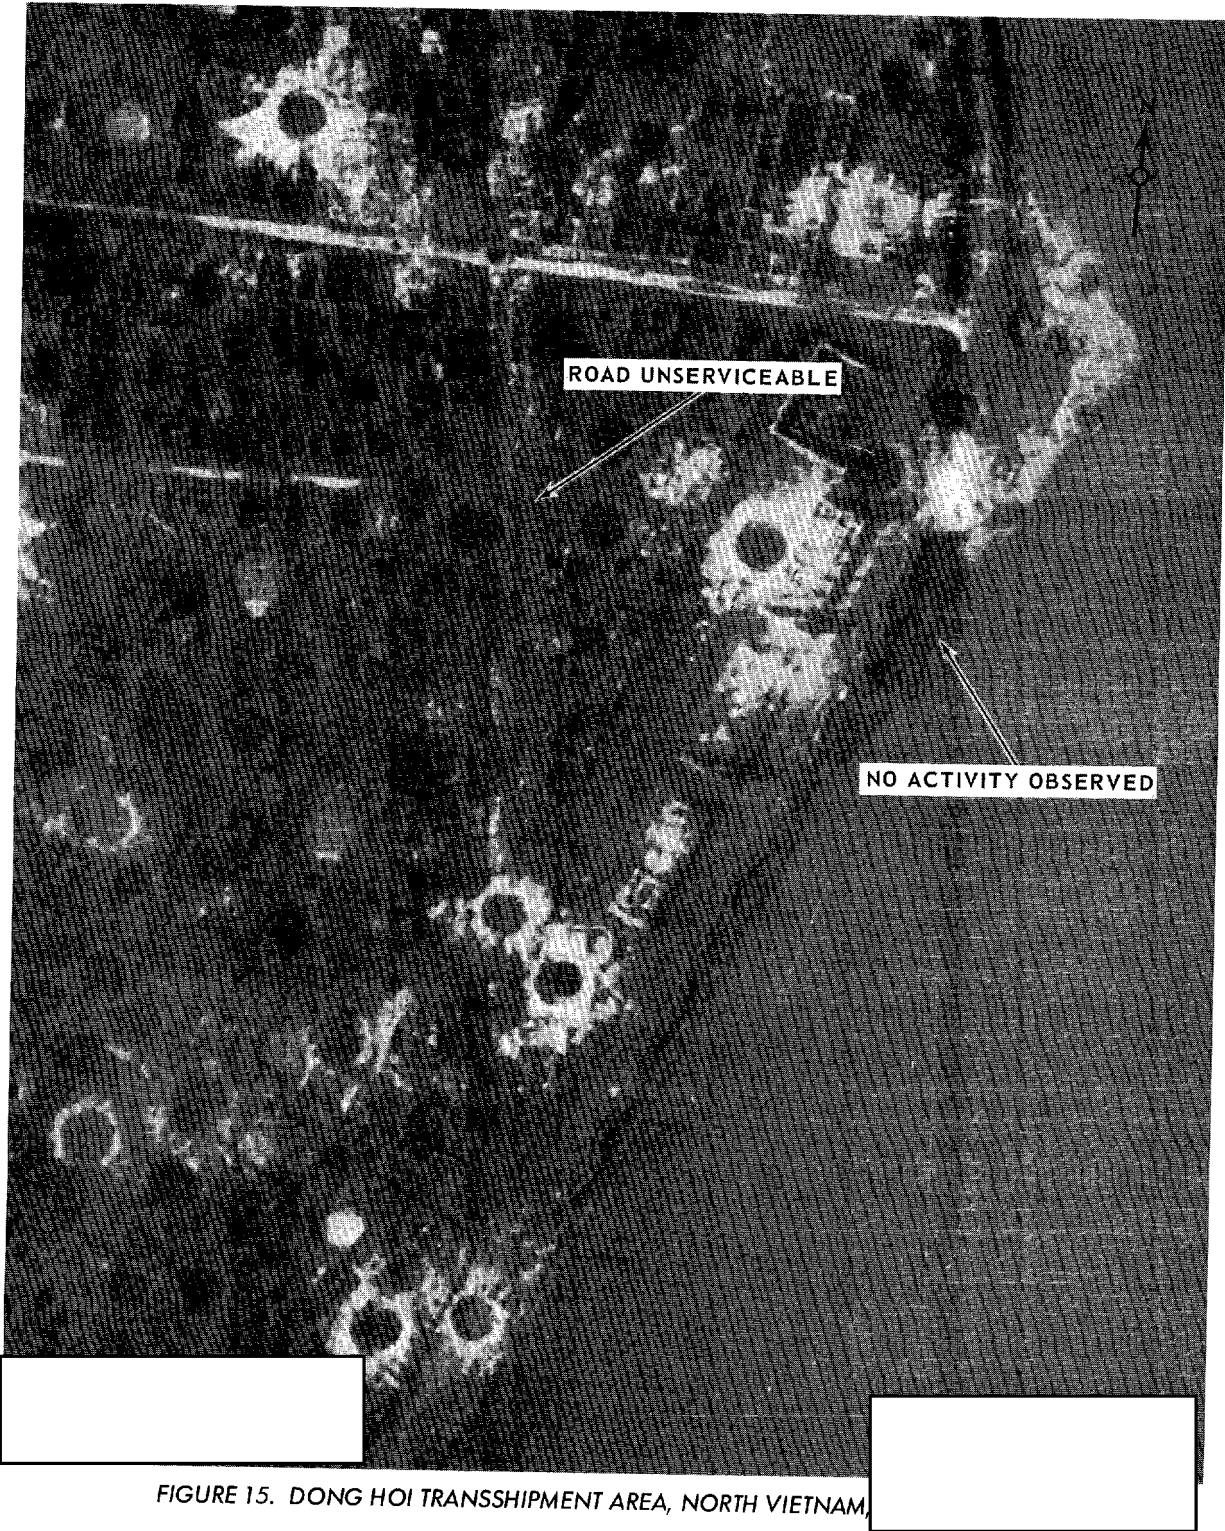
FIGURE 15. DONG HOI TRANSHIPMENT AREA, NORTH VIETNAM,

photography of Dong Hoi revealed no activity (Figure 15); however,

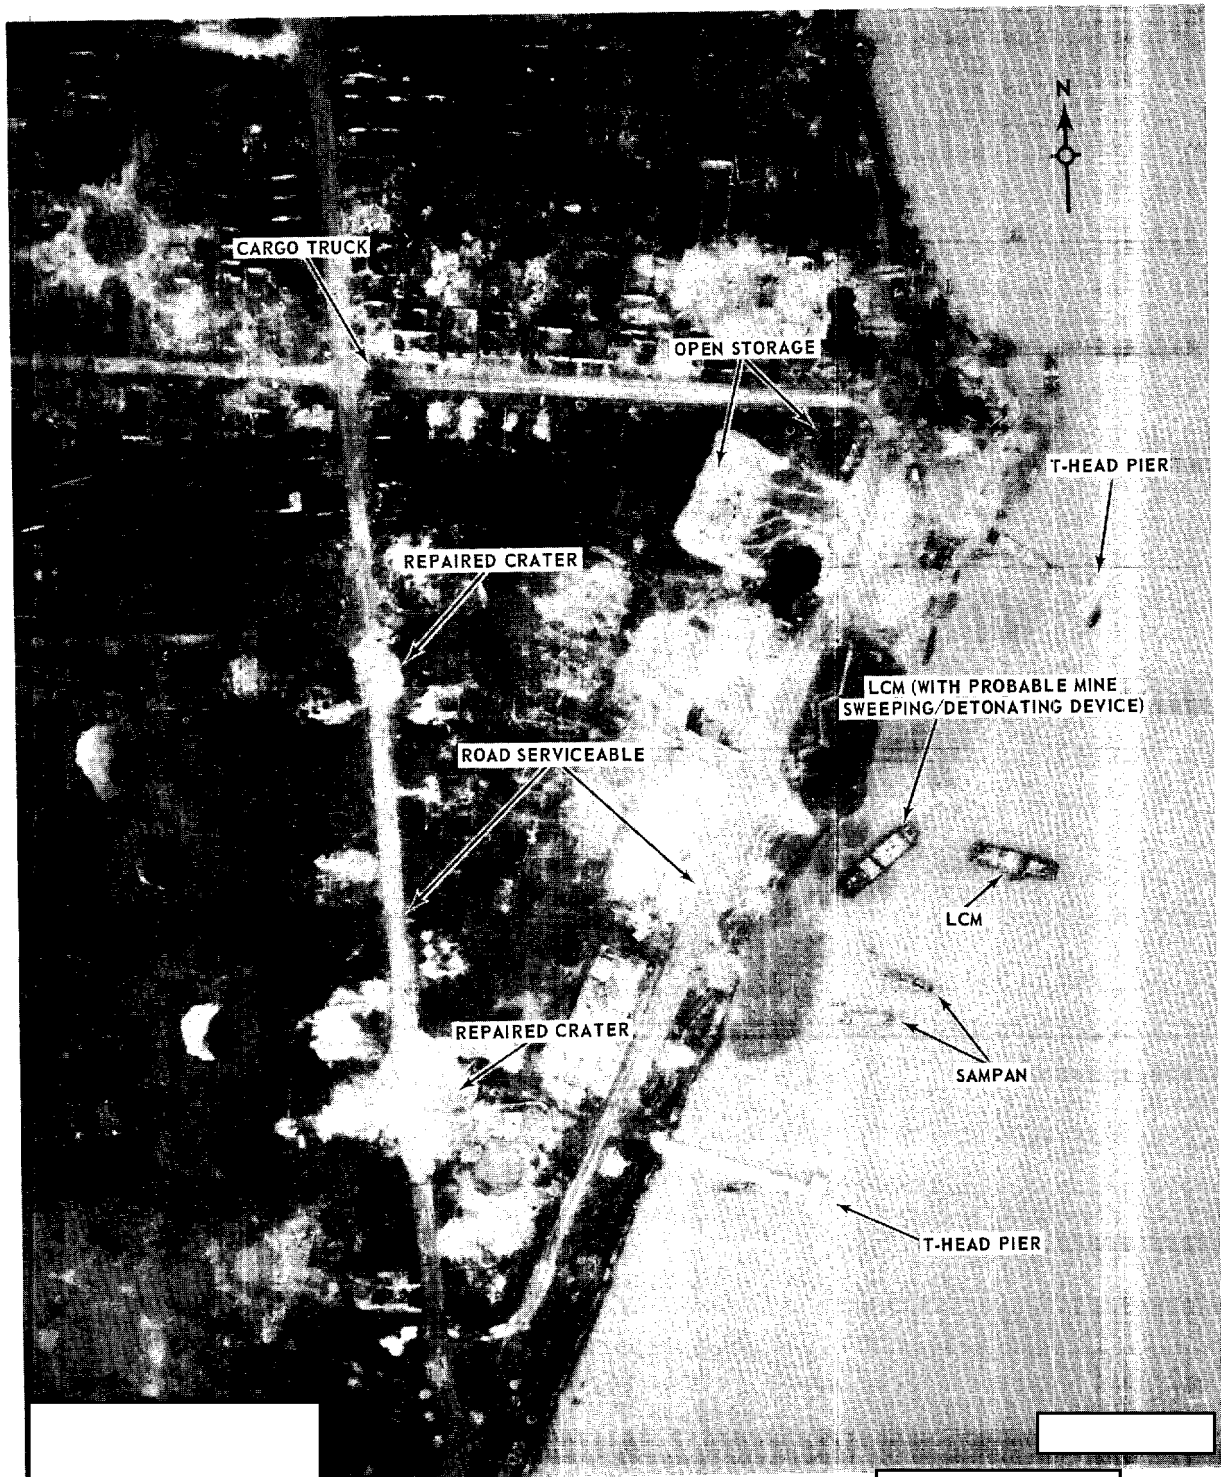
FIGURE 16. DONG HOI TRANSSHIPMENT AREA, NORTH VIETNAM

two T-head piers had been constructed 0.4 nm SW of the Dong Hoi Citadel and

a total of five T-head piers had been built. Several types of waterborne logistics craft, including LCMs, Type-46 coasters, and sampans, were observed active in the area. In addition, a ZIL-485 amphibious truck, numerous personnel, and several stacks of material in open storage were observed (Figure 16).

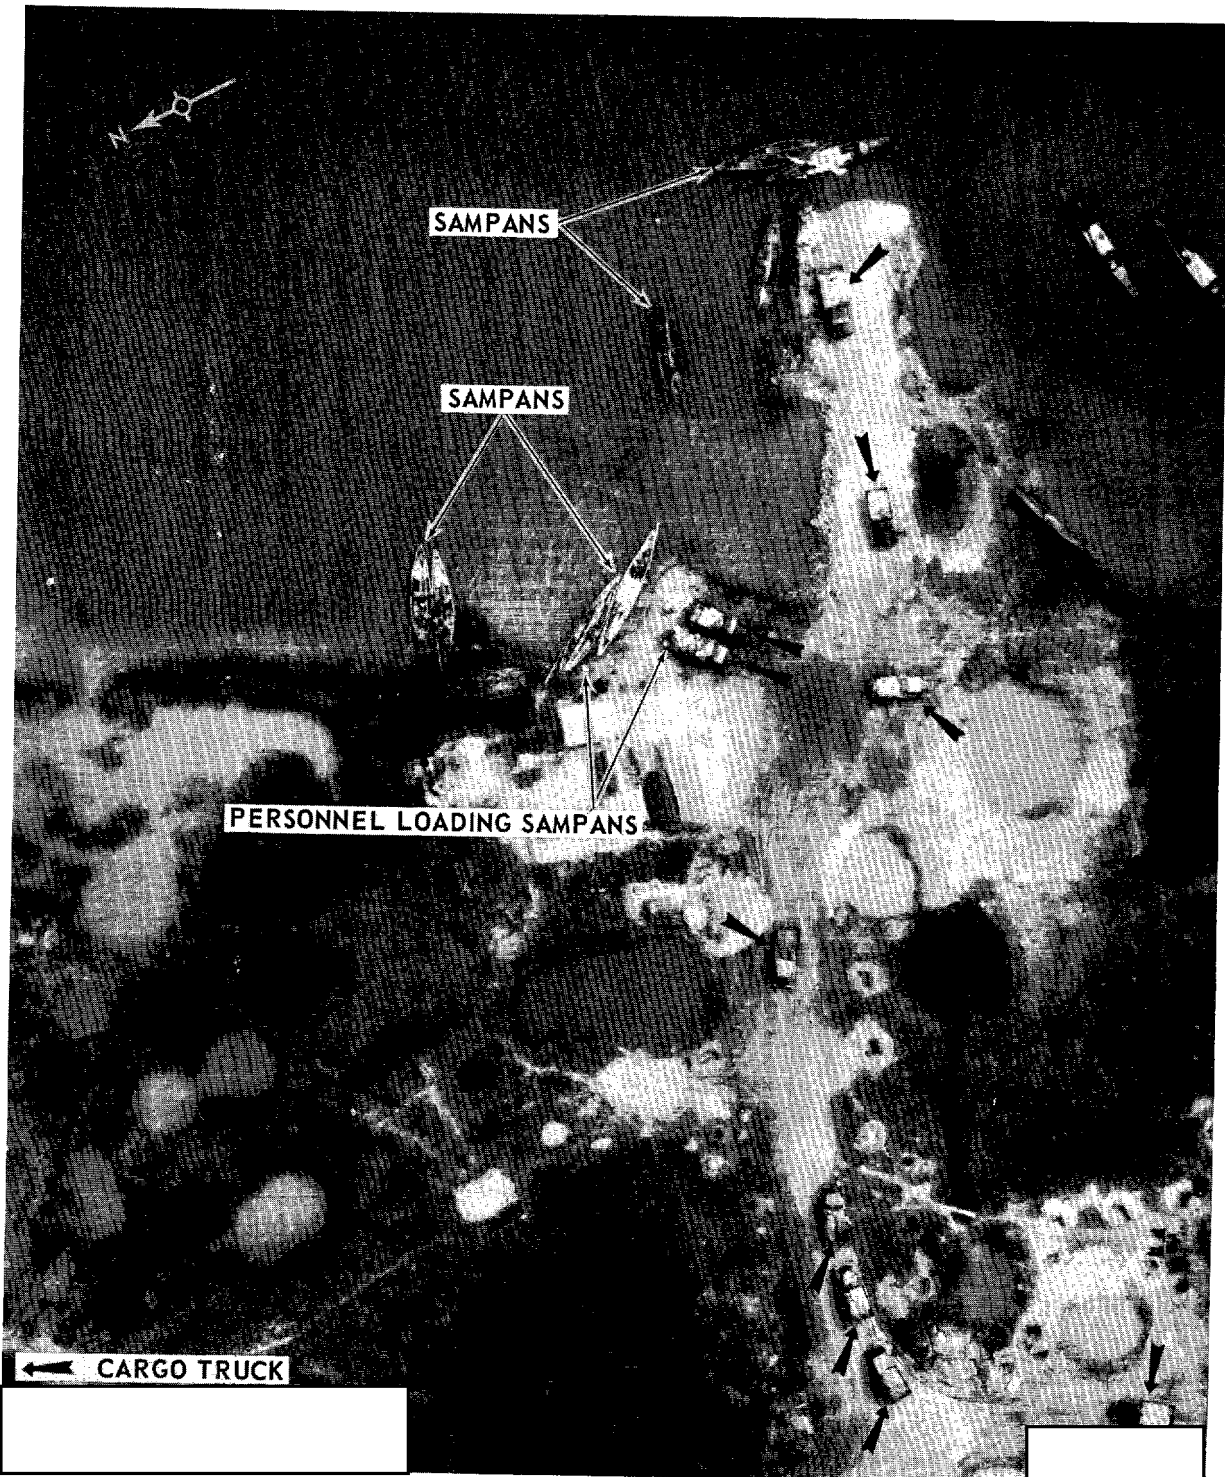
FIGURE 17. TRANSHIPMENT ACTIVITY, HUU HUNG RIVER CROSSING, NORTH VIETNAM.

names to move large amounts of supplies down the coast and directly into Dong Hoi. From there the supplies can be moved further south to other transshipment areas such as the one at the Huu Hung river crossing, 4 nm south of Dong Hoi. Activity at this transshipment area is newly observed on both sides of the Kien Giang (river). Supplies are being unloaded from trucks and loaded into sampans on the northwest bank, and then ferried to the southeast bank where they are apparently unloaded and the material stockpiled until cargo trucks are available (Figure 17).

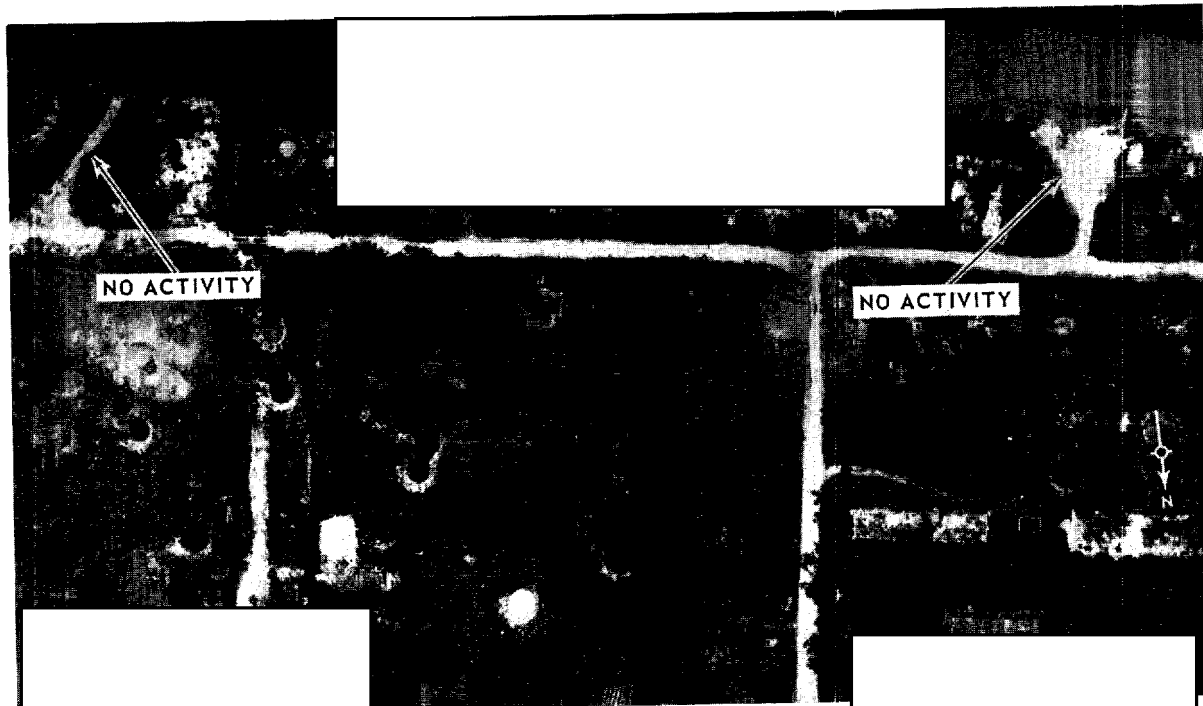
FIGURE 18. VINH TRANSSHIPMENT AREA, NORTH VIETNAM

Transshipment Point Song Vinh/Hoang Mai is known to have been used extensively until heavily damaged by airstrikes. Photographic coverage in [redacted] revealed no significant activity in the area (Figure 18). Photography [redacted] revealed a significant increase in daylight activity. At that time there were six non-motorized cargo barges moored in the transshipment area, one of which was in the process of being loaded from stockpiled materials (Figure 19). Barges loaded at this point are towed by motorized river craft down the Song Ca and its tributaries to other transshipment areas that are accessible to major overland routes.
